Case Studies of Landslides in India

Dr. Vinod Kumar*

Abstract

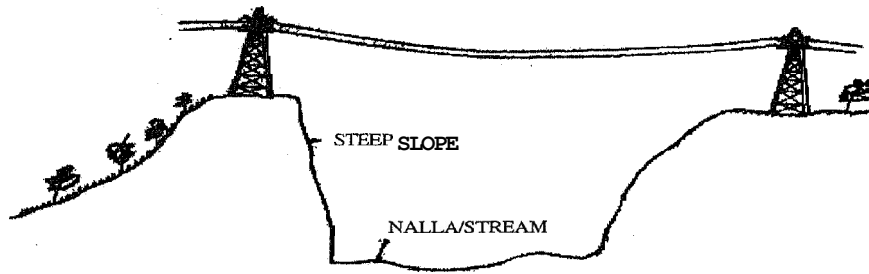
Figure 1: Typical Locations of Transmission Towers in Shiwalik Hills

typical sketch for the geographic location of these hills and the location of transmission towers is shown in figure 1.1. Slope stability problems were faced at about 15 locations in the area, where high voltage transmission towers of the

Punjab State Electricity Board (PSEB) were located. It was observed that some of the slopes were experiencing failures shortly after rainfalls [2].
